Geotechnical Forensic Investigations of a Gravity Dam: Addressing Seepage and Sliding Problems in the Basalt Foundations of Karjan Dam, Gujarat, India

Indra Prakash^{1*} & Binh Thai Pham^{2*}

Abstract: Geotechnical forensic engineering plays a crucial role in identifying and mitigating potential issues in large gravity dams. The Karjan Dam in Gujarat, India, a 100-meter-high gravity dam built 38 years ago on Deccan basalt, encountered significant geotechnical challenges during construction due to early investigation oversights. These oversights failed to detect sub-horizontal weathered rock seams within the basalt during the pre-construction investigations, which could have posed significant seepage and sliding risks during the dam's operation. Subsequent detailed investigations during the construction phase revealed that these seams extended throughout the foundations of the dam blocks.

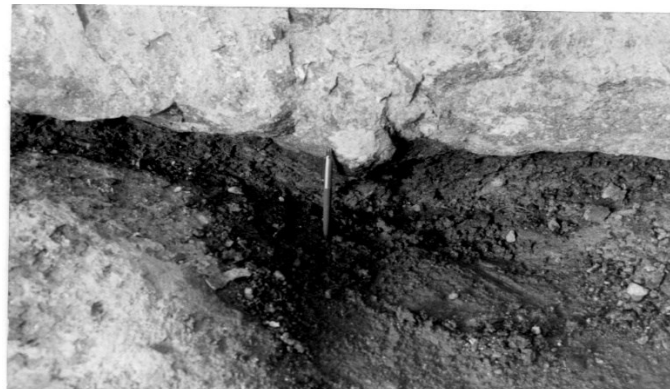
Characteristically, weathered rock seams consist mainly of highly to completely weathered basalt, often accompanied by a thin layer of clayey material. These seams exhibit a distinct morphology with a wavy, branching pattern that includes areas of pinching and swelling (Fig. 4). Their thickness varies significantly, ranging from a few millimeters to 1.5 meters. In some cases, infillings of minerals like zeolite or calcite are observed within these seams. Slickensided surfaces along these seams suggest localized movements and displacement, identifying them as potential weak planes vulnerable to structural

Fig. 3. Weathered Rock Seam developed along the contact of two flows (Adopted from [10])

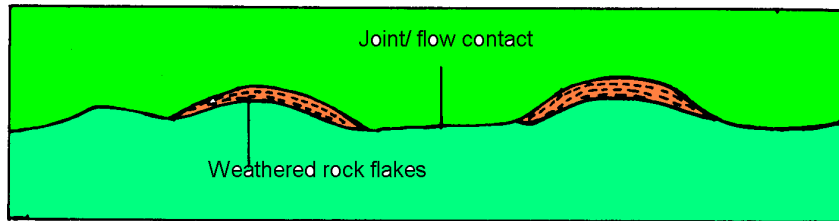
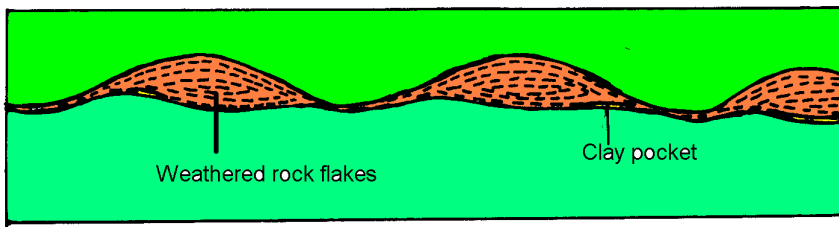
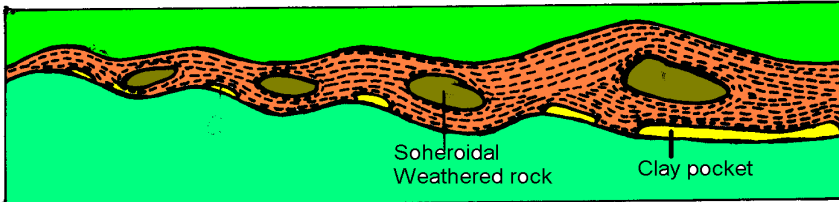
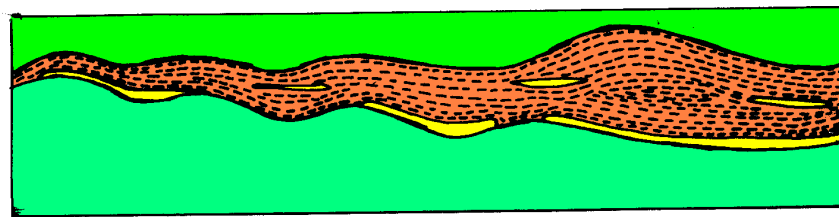
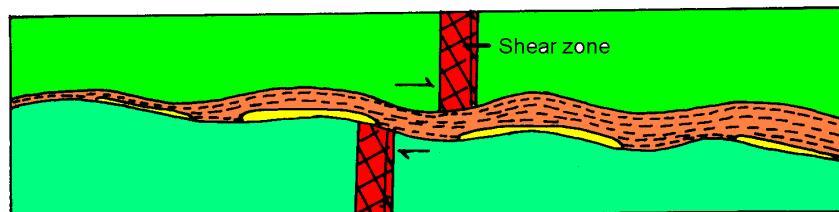
Fig. 4. Varied Characteristics of Weathered Rock Seams in Basalt Foundation

Type-I: Partly developed seam along joint/ flow contact

Type-II: Pinching and swelling seam

Type-III: Seam with spheroidal weathered rock

Type-IV: Thick seam without spheroidal weathered rock

Type-V: Seam associated with slickensided surface due to movement

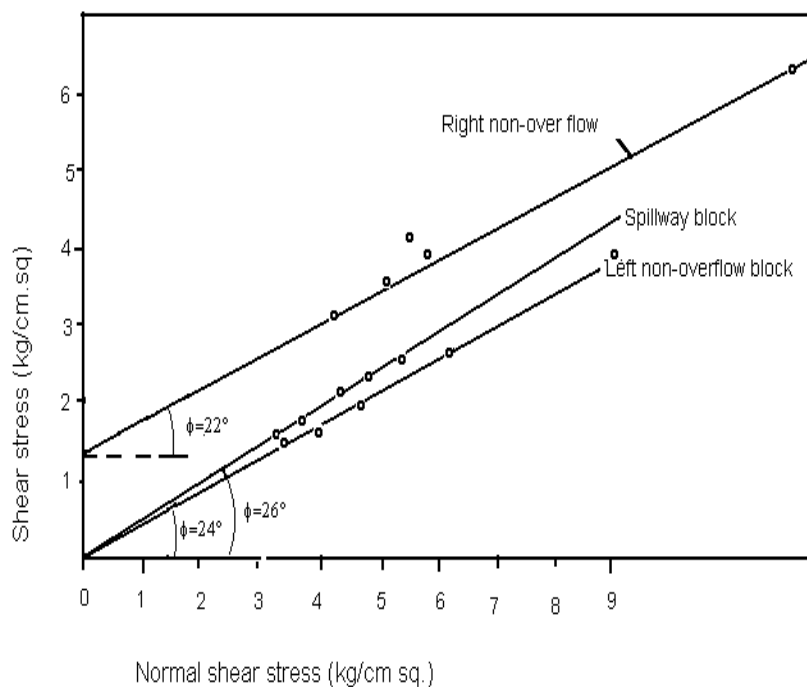
Fig. 6. In-situ shear tests plot of Normal shear stress vs. shear stress of weathered rock seam (Adopted from [6]).

In-situ shear tests were conducted to determine shear parameters of weathered rock seams. Seven test blocks were prepared in the spillway Block No. 5, over weathered seam. To facilitate the tests these rock blocks were encased in concrete. Test results showed the C value of 0 Kg/cm² and an ϕ value 22° to 26° (Fig. 6). Due to low shear parameters, concrete shear keys were

provided along and across the weak layers in the dam foundation to resist sliding forces [12]. A higher value of 26 degrees was used in the design of this treatment. This decision was based on expert judgment, considering the wavy nature of the seams, which would increase resistance against sliding.

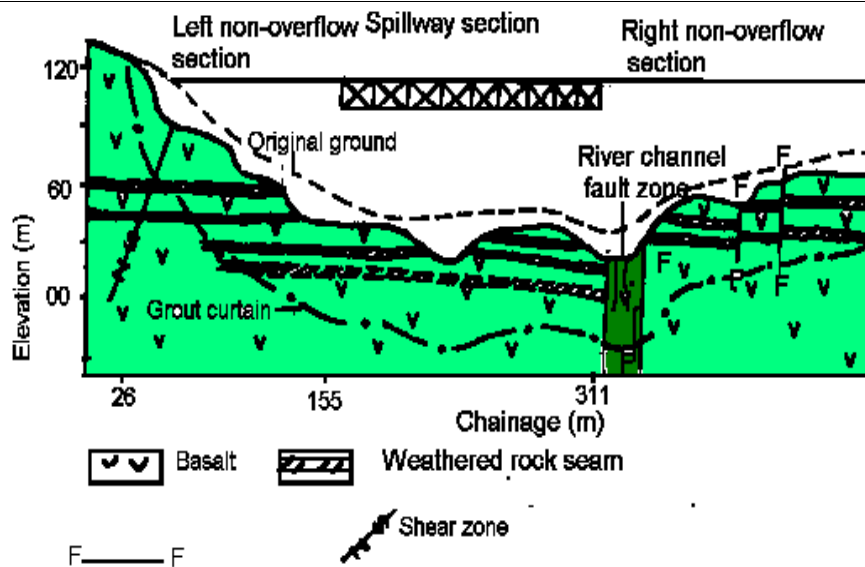
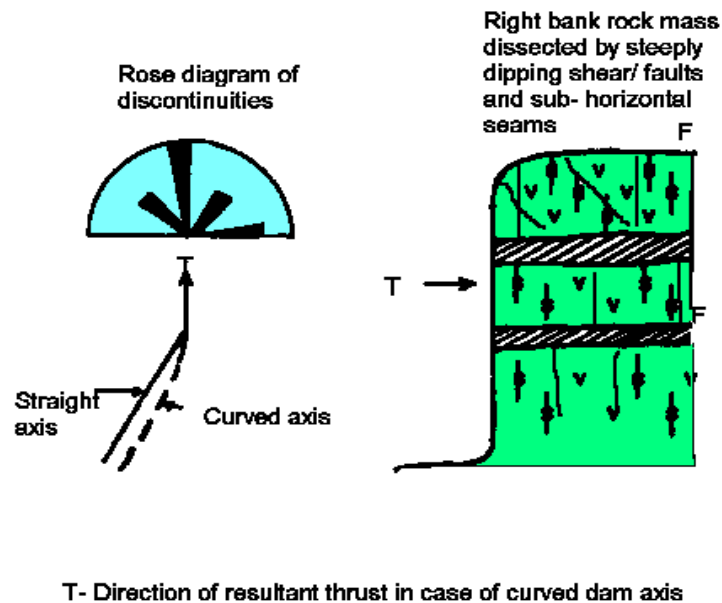
Fig. 7. Unfavourable geological conditions for proving curvature in the axis of spillway blocks: 1. Sub horizontal weathered rocks seams in the foundations 2. Sheared and weathered abutment rocks
(Adopted from [6])

Based on the stability analysis following Shear Friction Factor (SFF) values obtained for Overflow and non-overflow blocks under different loading conditions are mentioned in Table 1. The Table 1 illustrates that the required SFF values were met only for the non-overflow blocks, where sufficient downstream rock cover was present. Notably, exceptionally high SFF values (greater than 22.969) were observed for the right non-overflow blocks 18 and 21, where approximately 20m of rock cover was available over the seam on the downstream side. On the other hand, there was not much available downstream rock cover in the spillway blocks due to unfavourable disposition of the seam. To enhance the SFF of dam blocks, the treatments designed and implemented include concrete shear keys extending below the weathered seams, widening the base width of dam blocks, and flattening the upstream slope of the spillway blocks. Curvature in the axis of the spillway blocks was not considered in view of the sheared and weathered nature of the abutment rocks [12] (Fig.7).

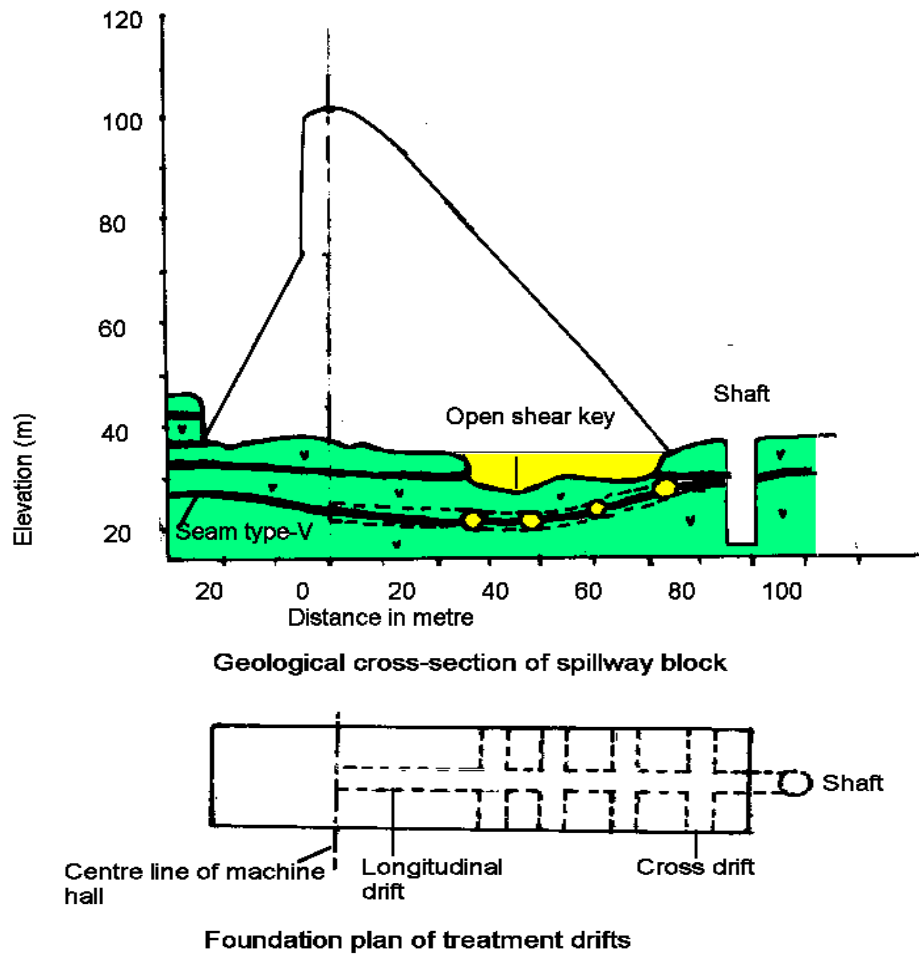
Fig. 8. Treatment of Weathered rock seams: Open concrete shear keys at shallow depth and underground concrete shear keys at depth (Adopted from [6]).

Open concrete shear keys were provided where seams were located at shallow depths, and concrete drifts (plugs) were provided where there was sufficient rock cover over the seam or where dam blocks were already partially constructed. This approach ensured that the stability and safety requirements were met effectively [8].

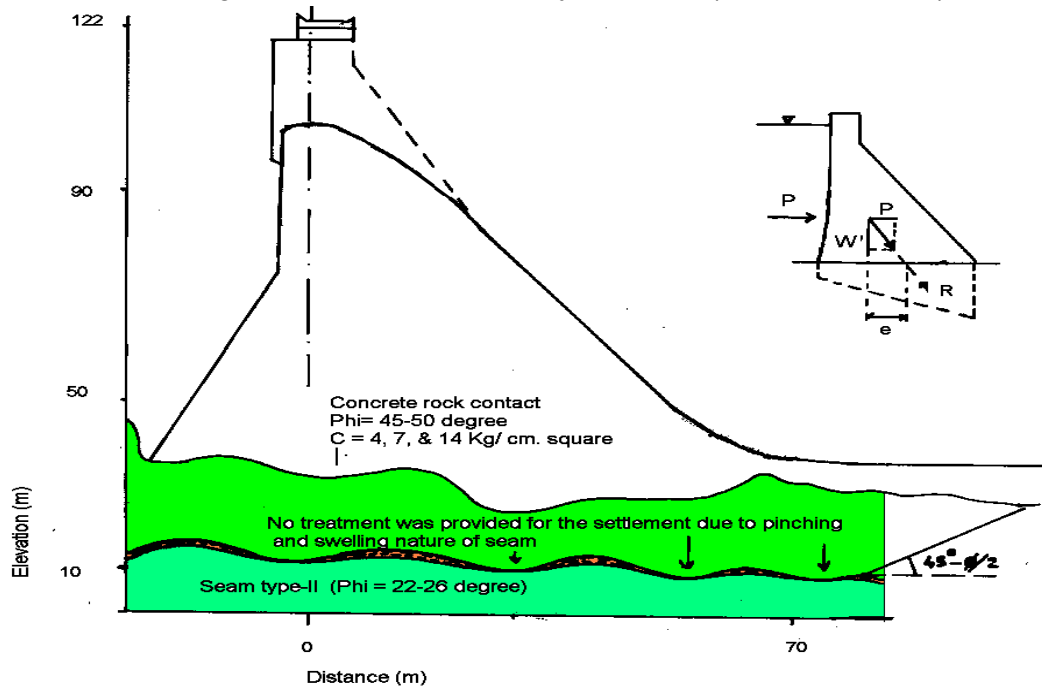
Fig. 9. Downstream Rock cover was considered in the Non-overflow blocks in the stability analysis (Adopted from [6]).

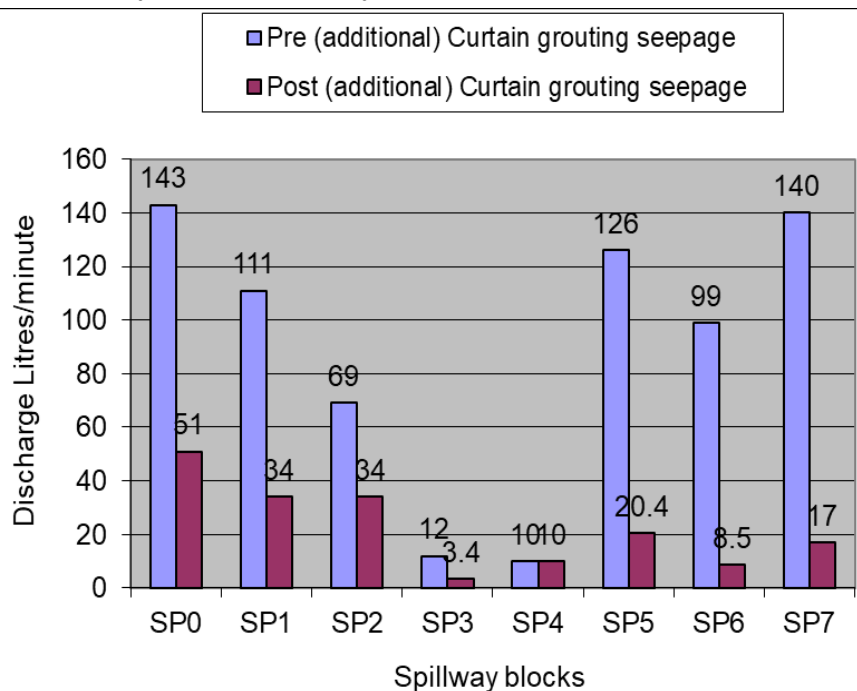
Conspicuous seepage was observed through weathered rock seams during the excavation of shafts and drifts in the foundations of spillway blocks [14]. Nearly all the drill holes during pre-construction stage investigations recorded high permeability (upto 75 Lugeons). To reduce the permeability of foundation rock mass, initial curtain grouting was done in four stages with 5,10,15 and 20kg/cm² pressures, gradually increasing with depth. Depth of curtain grouting in spillway section varied from 42 to 60m. It was observed that in five spillway blocks post-grouting seepage was more than 100 litres/minute. It clearly indicated ineffectiveness of initial curtain and consolidation grouting. Therefore, to reduce the seepage and to seal remaining gaps/permeable windows in the

Fig. 10. A comparative study of pre and post curtain grouting seepage results: Reduction in seepage was observed after curtain grouting in the foundation of spillway blocks (Adopted from [6]).

grout curtain additional curtain grouting was done with uniform high pressure of 20kg/cm² in all the stages, after filling of the reservoir upto El.78m. Seepage was reduced in general by about 70 to 90% after providing additional curtain grouting [15] (Fig. 10).

Conspicuous seepage was observed through weathered rock seams in the foundation of the Karjan Dam. Low-pressure consolidation and curtain grouting were initially ineffective in treating these seams. However, seepage was significantly reduced by adopting high-pressure (20 kg/cm²) curtain grouting (Fig. 10).
