Degradation mechanism in dispersive-soil earthen dams under climatic conditions: A case study from Song Sat reservoir, Khanh Hoa, Vietnam

Abstract: The safety of earthen dams remains a critical global concern, particularly in the context of climate change and the increasing frequency of extreme weather events. Highly dispersive soils and climate stress in South Central Vietnam are causing dam degradation and downstream slope failure. The combined approach, which involves both field observations and laboratory experiments, is employed to provide a comprehensive understanding of the underlying mechanism. The statistical results elucidate the annual progression in the number and size of sinkholes, thereby revealing patterns of erosion development over time and in relation to climatic conditions. In which the number of sinkholes on the downstream slope increased from 20 in 2014 to 626 in 2023, a rise of more than 30-fold, including a sharp seasonal escalation of over 70% during the 2020–2023 rainy periods alone. In parallel, laboratory tests-including Pinhole, Crumb, and Exchangeable Sodium Percentage (ESP) tests-were conducted to confirm the strong dispersivity of the dam fill soil,

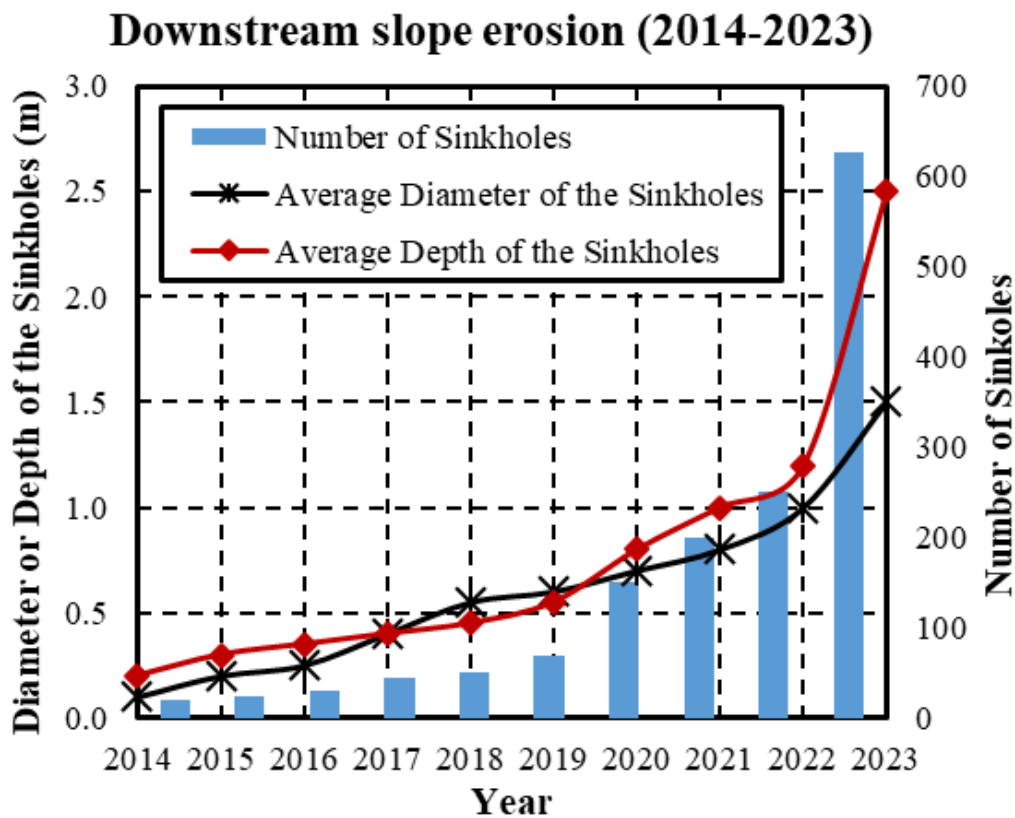
Fig. 2. Variation in the number of sinkholes from 2014 to 2023

The analysis of downstream-slope erosion over the past decade was derived directly from the long-term field monitoring program outlined in Section 2, which included annual surveys, GPS-based mapping and sinkhole inventory datasets collected from 2014 to 2023. Table 1 and Fig. 2 summarize the number and average sizes of erosion pits in the period of from 2014 to 2023.

Year	Number of Erosion Pits (sinkhole)	Average Diameter (m)	Average Depth (m)
2014	20	0.10	0.20
2015	25	0.20	0.30
2016	30	0.25	0.35
2017	45	0.40	0.40
2018	50	0.55	0.45
2019	70	0.60	0.55
2020	150	0.70	0.80
2021	200	0.80	1.00
2022	250	1.00	1.20
2023	626	1.50	2.50

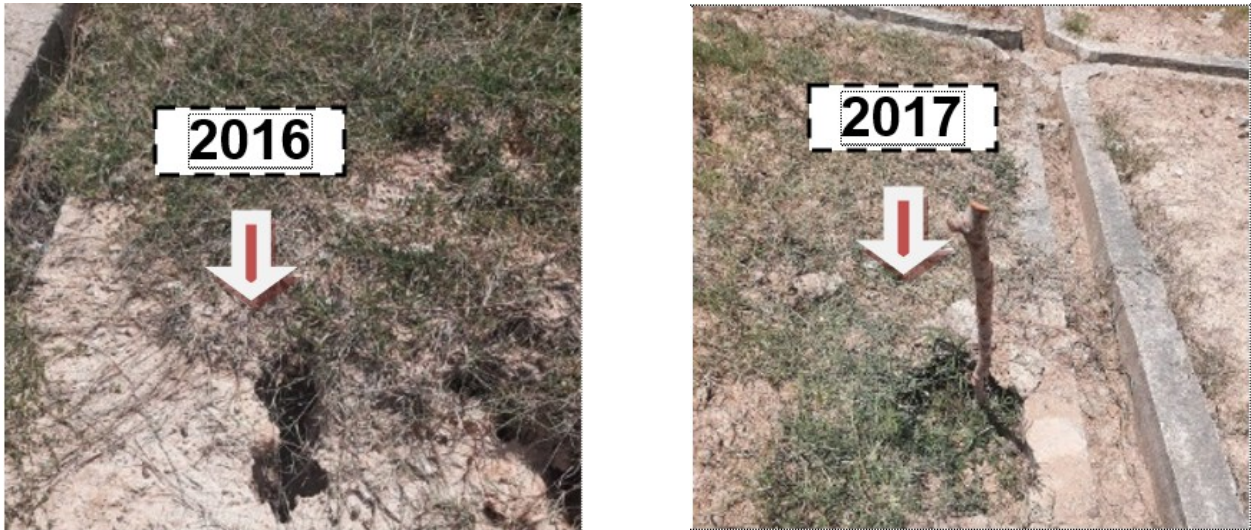
Fig. 3. Sinkhole formation on the downstream slope of the dam during 2014–2017

Period 2014–2017: This period recorded the initial signs of slope erosion, particularly after the heavy rainfall season in 2016, during which recorded rainfall reached up to 96 mm in a single event [14]. Numerous small surface cracks and shallow erosion gullies were observed, along with the formation of initial sinkholes ranging from 0.2 to 0.5 meters in diameter, typically located along natural drainage paths (Fig. 3). This can be explained by prolonged drought, the surface layer of the downstream slope experienced significant desiccation and cracking, leading to a reduction in shear strength and increased infiltration potential. When intense rainfall occurred abruptly, water rapidly penetrated through the cracks, generating elevated pore water pressure, which in turn triggered soil disintegration and localized erosion—especially in the central and lower portions of the downstream slope. Despite of limited scale, these signs served as an early warning for more severe erosion stages in subsequent years. This phenomenon aligns with similar observations reported in Australia, where desiccated clay soils

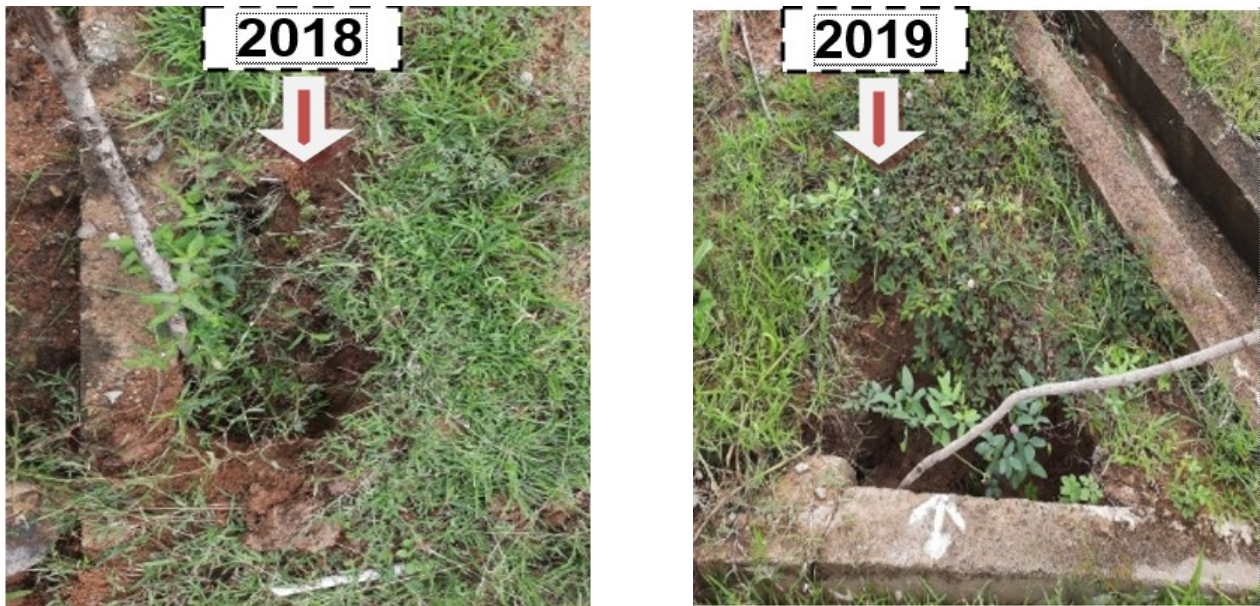
Fig. 4. Sinkhole formation on the downstream slope of the dam during 2018–2020

Period from 2018 to 2020: Since late 2018, erosion on the downstream slope of the dam has become increasingly severe, with significant expansion in both scope and scale. The primary cause stems from mentioned climate condition, combined with an ineffective drainage system and heterogeneous geological conditions. Concentrated surface runoff and internal erosion weakened the soil structure, leading to the

formation of deep gullies and large sinkholes (diameters ranging from 0.5–1.0 m), mainly in the middle and lower parts of the slope (Fig. 4). Field monitoring documented the interconnection of sinkholes, forming continuous erosion networks and significantly compromising the protective soil layers. Similar phenomena have been reported in China, where heavy rains following droughts caused internal voids and sinkholes in many earthen dams [17].

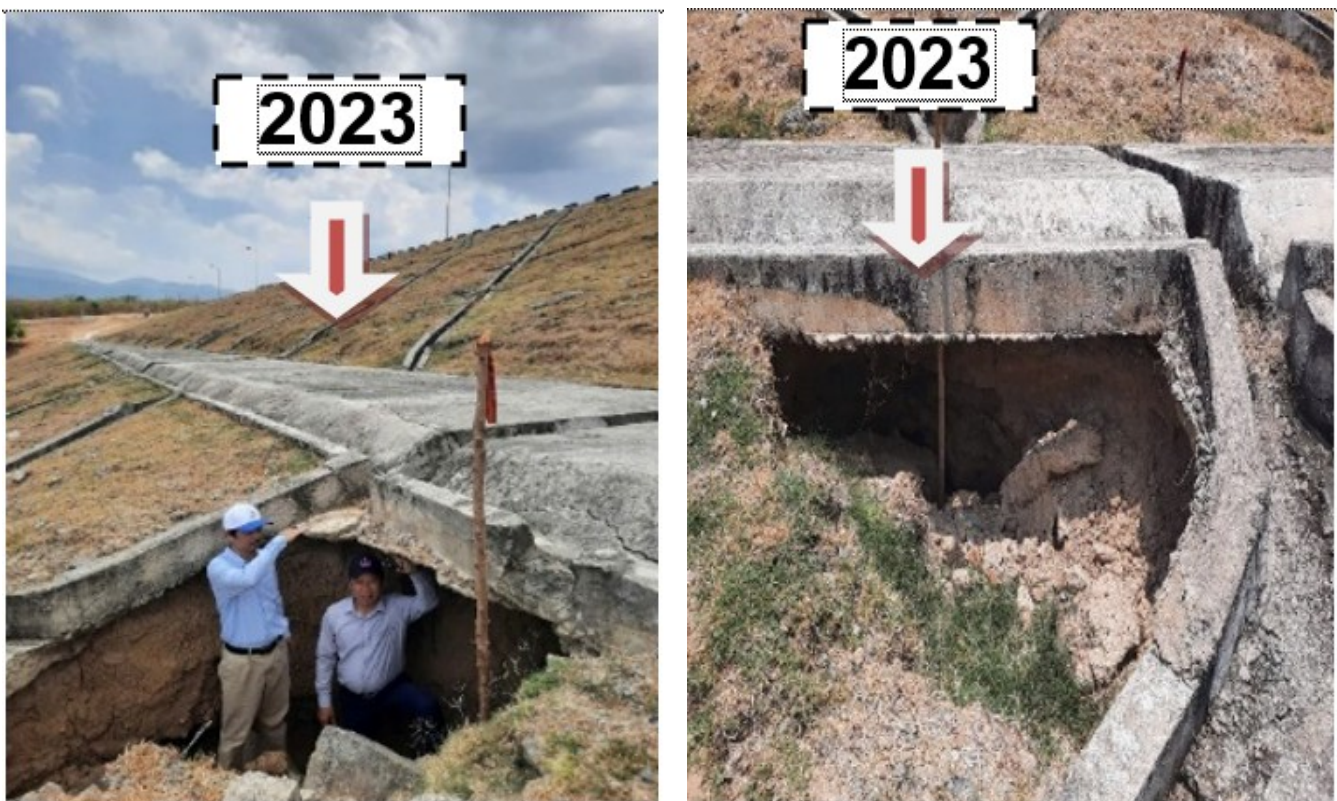
Fig. 5. Sinkhole formation on the downstream slope of the dam during 2020–2023

Period from 2020 to 2023: Within this timeframe, the province was affected by approximately 14-17 tropical storms and depressions, including both storms making direct landfall in the South Central region and storms whose circulation systems induced heavy rainfall and strong winds over the province [18]. Significant events include Sinlaku, Linfa, Nangka; Conson Dianmu. The inadequate drainage system, combined with soil strength degradation caused by years of disintegration, led to waterlogging, increased pore water pressure, and deep percolation that triggered severe internal erosion. Numerous large sinkholes (with diameters ranging

from 0.5–3.5 m and depths up to 2.5 m) were recorded across the downstream slope (Fig. 5). These sinkholes were not isolated but increasingly interconnected, forming a subsurface void network that compromised the dam's structural integrity and significantly elevated the risk of large-scale slope failure. Several areas experienced sudden collapses and massive slumping, putting the entire structure at extreme risk. By November 2023, a total of 626 sinkholes had been documented, including 67 with diameters exceeding 1 meter (Fig. 6). Despite emergency backfilling and temporary reinforcement efforts costing nearly VND 1 billion, the solutions proved unsustainable,

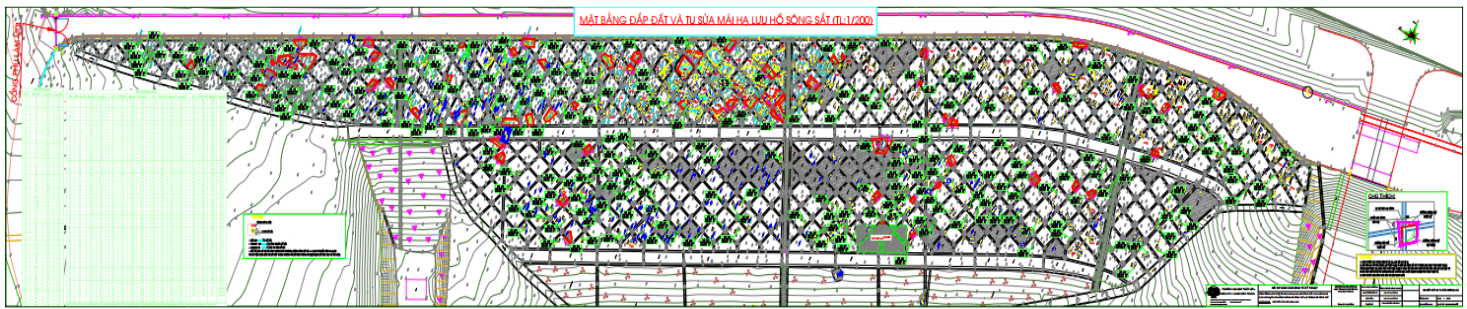
Fig. 6. Locations of 626 sinkholes (red cross) identified on the downstream slope of the earthen dam in 2023

end of 2023 as part of emergency mitigation measures. However, in 2024, approximately 390 new sinkholes were observed to re-form on the downstream slope.

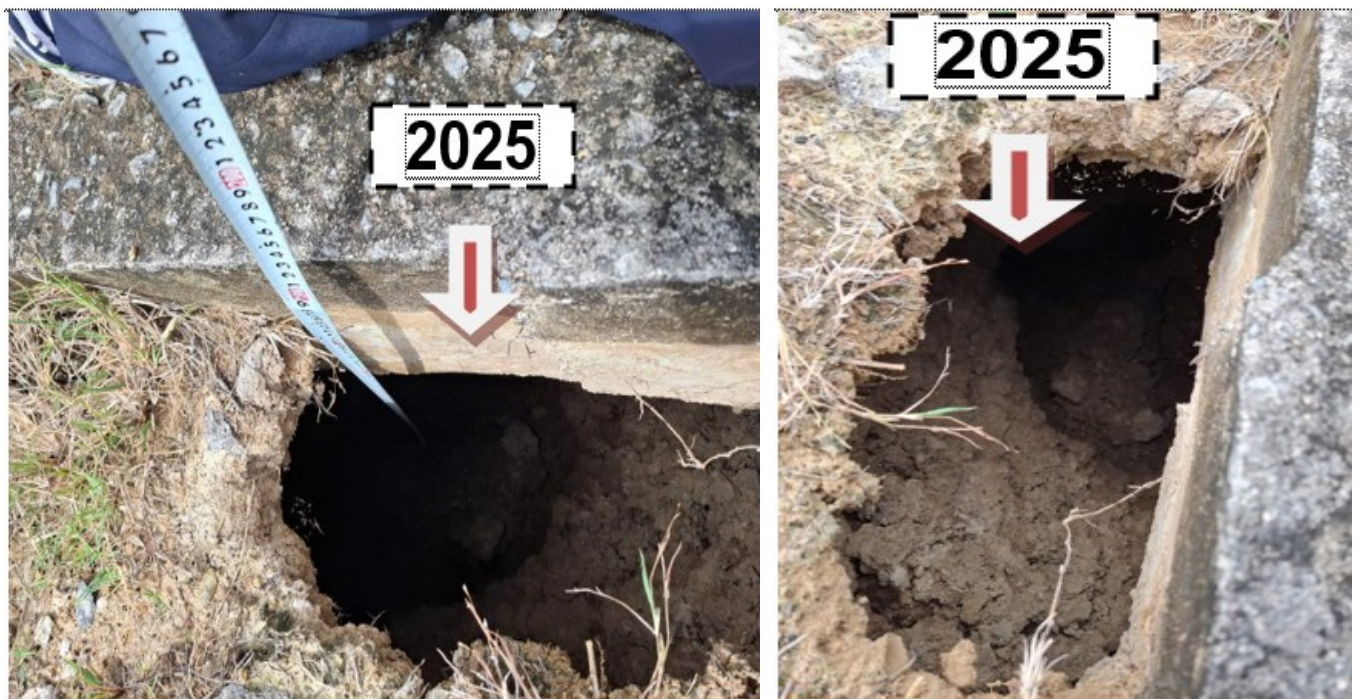
Fig. 7. Photographs of sinkholes on the downstream slope of the dam in 2025

Period from December 2024 to Present: In the nearest period, the implementation of temporary reinforcement measures, erosion intensity has shown signs of reduction in some treated areas. However, sinkhole formation has continued to develop in untreated zones or at the boundaries between reinforced and unreinforced sections. Field observations up to early 2025 recorded 390 active and expanding sinkholes, many of which measured 0.5–1.0 m in diameter and up to 1.5 m in depth, indicating a persistently high risk of erosion (Fig. 7, Fig. 8 & Table 2). These findings confirm that the current interventions are only temporary in nature and insufficient to fully control the problem without a more comprehensive and sustainable approach moving forward.

Most of the previously identified sinkholes were backfilled and temporarily stabilized at the

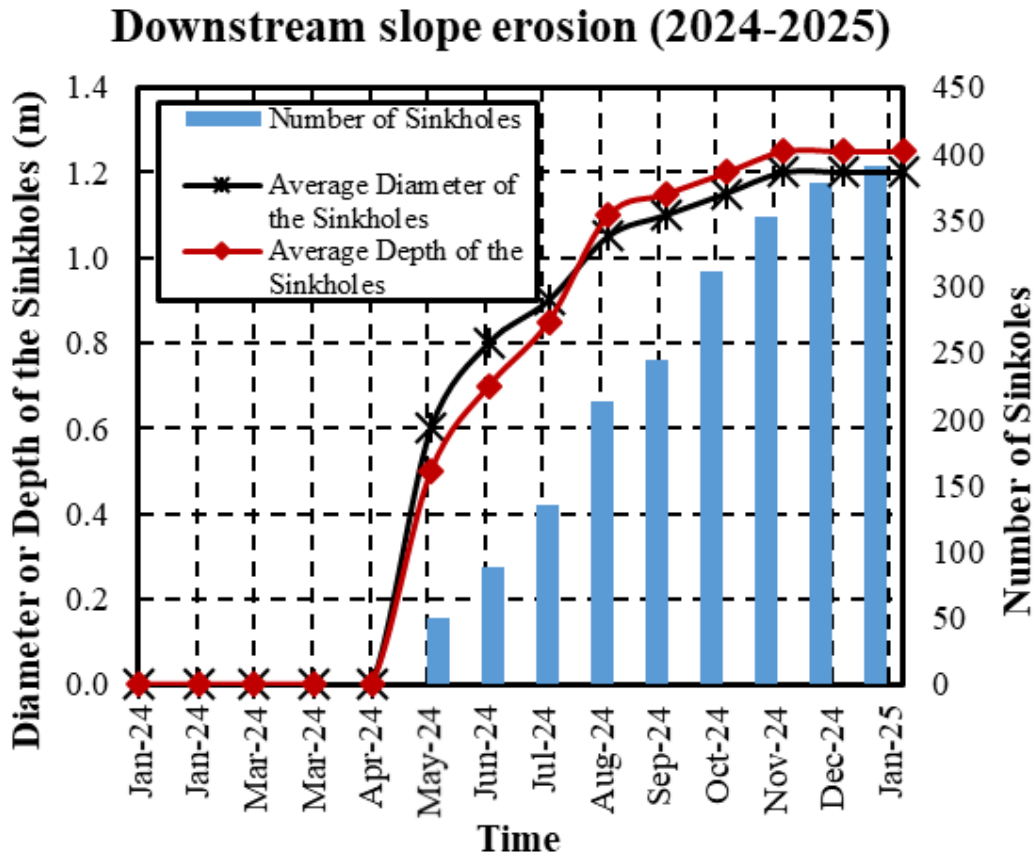
Fig. 8. Evolution of Sinkhole Quantity from Jan 2024 to Feb 2025 of the earthen dam in 2025

Year	Number of Erosion Pits (sinkhole)	Average Diameter (m)	Average Depth (m)
1-2024	0	0.00	0.00
2-2024	0	0.00	0.00
3-2024	0	0.00	0.00
4-2024	0	0.00	0.00
5-2024	0	0.00	0.00
6-2024	50	0.60	0.50
7-2024	89	0.80	0.70
8-2024	135	0.90	0.85
9-2024	214	1.05	1.10
10-2024	245	1.10	1.15
11-2024	311	1.15	1.20
12-2024	352	1.20	1.25
1-2025	378	1.20	1.25
2-2025	390	1.20	1.25

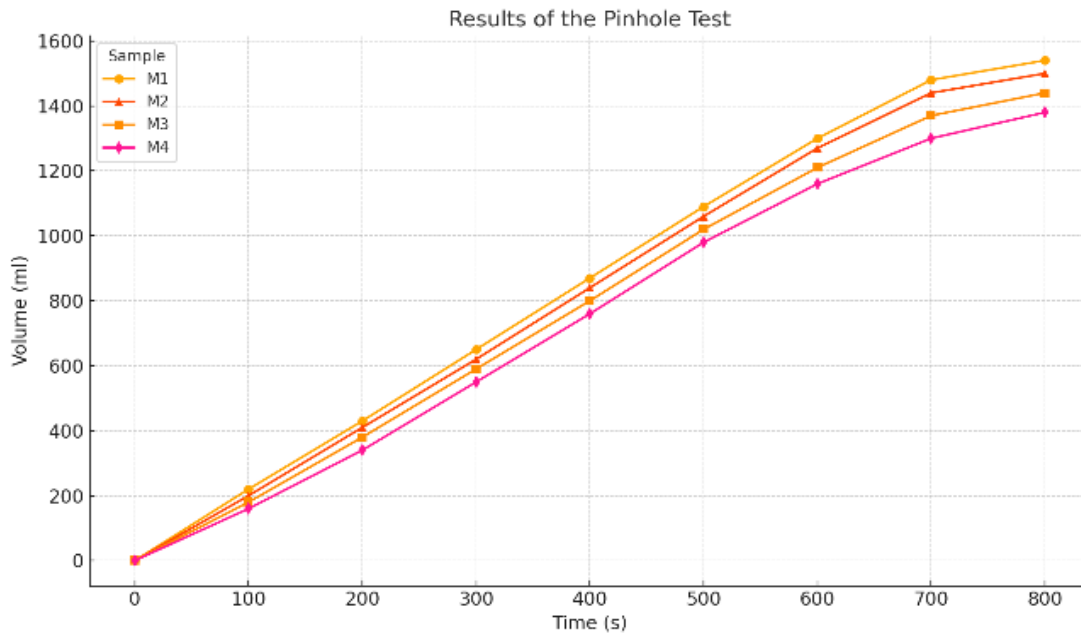
Four soil samples of the earthen dam materials at Song Sat Reservoir were applied Pinhole Test. The test progression was summarized using the results shown in Fig. 9 and Table 3.

The erosion time (t) increases monotonically with flow volume (V) for all samples, indicating progressive pinhole enlargement under sustained seepage. Sample S3 exhibits the shortest erosion times and the highest turbidity (398 NTU), reflecting the strongest soil dispersion and internal erosion susceptibility, whereas S1 and S4 show relatively lower erosion intensity. The consistent relationship between shorter erosion time and higher turbidity confirms that particle dispersion

governs the rate of internal erosion development. Consequently, all tested soils are classified as

dispersive (D), with varying degrees of erosion severity.

Fig. 9. Variation of Water Volume Through the Pinhole Over Testing Time

The enlargement of the pinhole could not be observed due to sample disintegration upon saturation and removal from the apparatus. Based on the two observable criteria-water turbidity and discharge rate through the pinhole-all four samples were classified as dispersive soils, indicating a high

vulnerability of the embankment materials at Song Sat Dam to internal erosion.

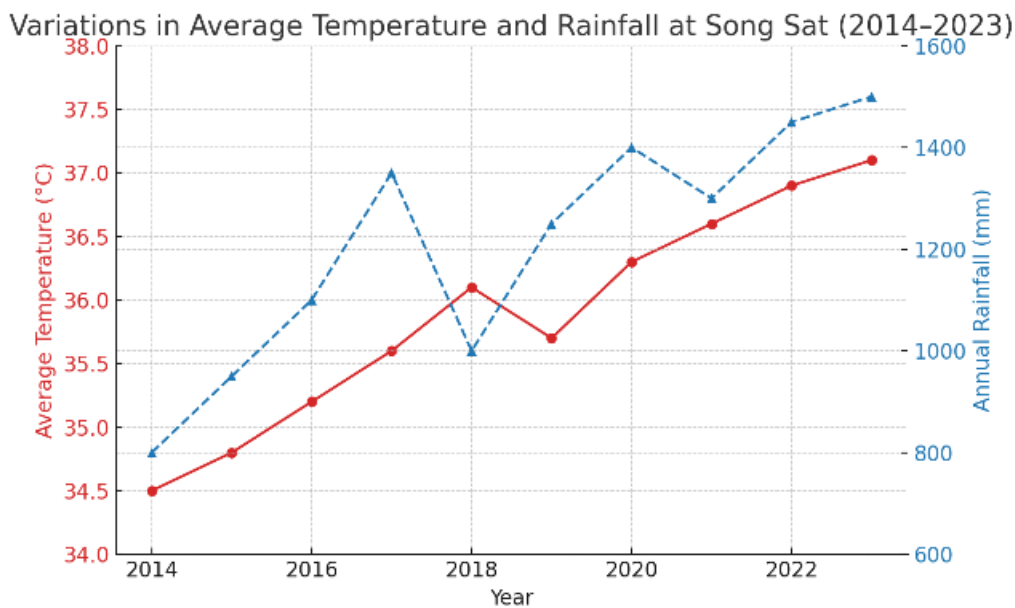
Fig. 10 illustrates the overarching annual variations in average temperature and rainfall from 2014 to 2023, further illustrating the impact of climate conditions on the structural degradation of the embankment. Within each recorded year, the region experiences a harsh and prolonged dry season spanning 6 to 8 months (normally January to August) [23], and the average temperature increased significantly, even reaching 37% in 2023, leading to intense moisture loss and deep vertical cracking in the clayey-sandy soil of the downstream slope.

Fig. 10. Variations in average temperature and rainfall at Song Sat (2014–2023)

At the onset of the rainy season, intense rainfall (200–300 mm over several days) infiltrates rapidly through these cracks, resulting in abrupt

moisture differentials between surface and subsurface layers. This sudden imbalance fractures the soil structure and triggers the formation of sinkholes and erosion gullies.
