Geotechnical Forensic Investigations of a Gravity Dam: Addressing Seepage and Sliding Problems in the Basalt Foundations of Karjan Dam, Gujarat, India

Indra Prakash^{1*} & Binh Thai Pham^{2*}

Abstract: Geotechnical forensic engineering plays a crucial role in identifying and mitigating potential issues in large gravity dams. The Karjan Dam in Gujarat, India, a 100-meter-high gravity dam built 38 years ago on Deccan basalt, encountered significant geotechnical challenges during construction due to early investigation oversights. These oversights failed to detect sub-horizontal weathered rock seams within the basalt during the pre-construction investigations, which could have posed significant seepage and sliding risks during the dam's operation. Subsequent detailed investigations during the construction phase revealed that these seams extended throughout the foundations of the dam blocks.

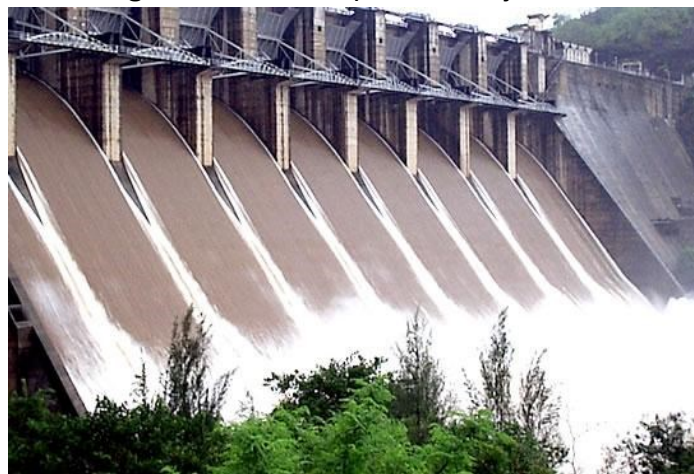
Fig. 2. Spillway of Karjan Dam under operation

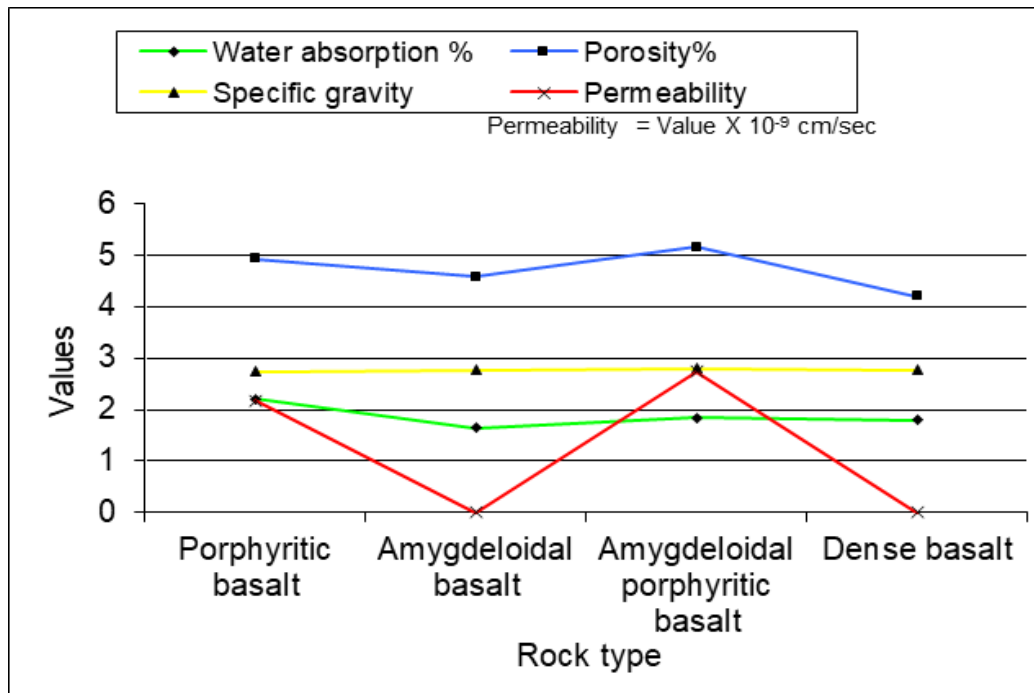
absorption percentage vary from 1.60 to 2.20, porosity 4.20 to 5.15, specific gravity 2.58 to 2.70, unconfined compressive strength 62 to 79 MPa, tensile strength 10 to 12.50MPa and permeability 0 to 2.73×10^{-9} cm/sec. These values are within the normal limit of fresh, moderate to good values of basalt [11] (Fig. 4).

Fig. 5. Physical Properties of Basalt Rocks at dam site (Adopted from [10])
